Assessment of 995 Trees at The Rise (Proposed Project) (Formerly known as Vallco Town Center Project) North Wolfe Road Cupertino, California

Site Visits:

Walter Levison, Consulting Arborist (WLCA)

Original 10/5/2015 Revised 6/14/2019, 3/23/2022, 12/4/2023

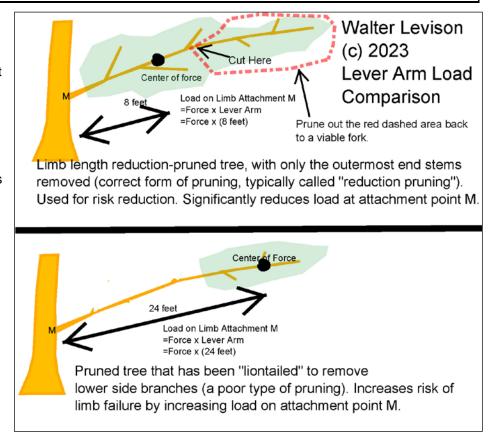
Past Liontail Pruning

Most of the ash trees at The Rise exhibit structural issues related to past liontail pruning. The trees exhibit multiple codominant mainstems arising from forks with relatively narrow angles of attachment. The trees were severely limbed up to remove many lower elevation live stems, resulting in remaining canopies that are oddly lopsided, top-heavy. and exhibit a high elevation center of gravity/center of force (COF): a situation which puts high loading on the stem attachment points (see WLCA diagram above right on this page, illustrating how liontail pruning increases risk of stem failure by changing the center of force to a location higher and farther out on stems, resulting in higher load on limb attachment, while correct stem length reduction pruning brings the center of force closer to the ground, reducing risk of stem splitout by reducing load on limb attachment.

These ash trees likely never received young tree training pruning to remove competing mainstems developing from the lowest elevation fork, which means that the trees developed multiple codominant mainstems arising from a single elevation such as 12 feet, 18 feet, etc.

The presence of many codominant mainstems arising from narrow attachment forks in each tree means that the mainstems are relatively more likely to split out (fail) from those narrow angle forks than would a normal tree with a single central leader stem or two codominant mainstems with wide fork angle of attachment. This situation somewhat elevates the risk of mainstem failure and impact with targets such as pedestrians, cars, and drivers. (TRAQ risk rating determination is outside the scope of The Rise report preparation assignment).

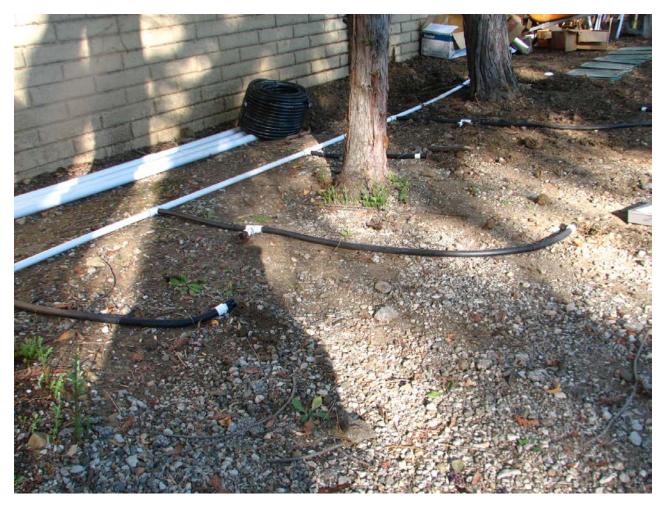
Above: Image of the new 2019 temporary flood bubbler irrigation system set over-grade along the west side of west perimeter road, with flexible UV-resistant Salco brand tubing cold-welded to white PVC main lines. This type of high flow system was built up throughout most of the entire The Rise project site in 2019.

Note: The team has been directed to place the bubblers as far as possible offset from the trunks of the trees, with the understanding that roots extend as much as 50 feet or more from the trunks. However, bubblers on the west perimeter road temporary tree irrigation system were required to be placed near to the trunks in order to allow for golf carts and other vehicles to pass over the root zone during site inspections and site maintenance work.

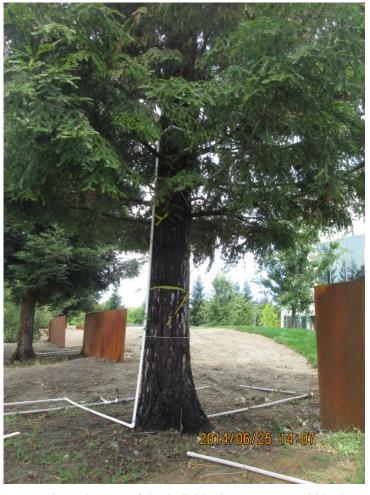
It is not clear whether tree vigor (new live twig and foliar growth) will be or can be boosted through either very heavy, sustained supplemental irrigation of the trees' root zones, or through natural rainfall finally occurring after the (existing) prolonged period of subnormal soil moisture. Generally, trees that have declined to an overall condition rating of poor (i.e. less than 40% overall condition rating) will not increase in vigor until very heavy irrigation is applied over an extended period of 6, 12, or even 18 months³ to the trees' entire root zone areas. Even after this type of serious irrigation regime commences and is continued for the extended period, the trees may still not respond favorably, and will continue to decline. High quality irrigation water with low ionic content needs to be available for supplemental irrigation of coast redwoods. See section 3.4 and 3.5 below for more information.

(WLCA update 3/23/2022): We have now experienced drought years through most of the individual water years within the period 2011-2022, as reported by NOAA and other government agencies. Our heavy irrigation of trees being retained at the project, using above-grade high flow type ½" diameter flood bubblers timed to emit water at a relatively high frequency and duration have boosted soil moisture to 70-100% for most trees on the site for a number of years now. This has resulted in relatively large percentage of the project site coast redwoods either stabilizing in terms of their overall condition ratings, or improving live twig extension and live needle density slowly over time. However, a similarly large percentage of the redwood specimens appear to have declined in terms of TDE, even after having been heavily irrigated year-round for multiple years via this piped over-grade water delivery system. Given that the species can still decline or possibly even die prematurely during a drought period in the Bay Area while being heavily irrigated year-round, I see this as clear evidence supporting WLCA's initial prognosis from 2015 that the existing perimeter redwood specimens need to be removed and replaced with trees such as drought-tolerant non-native oak species more suitable for long-term use at the project, with its dry summer type climate.

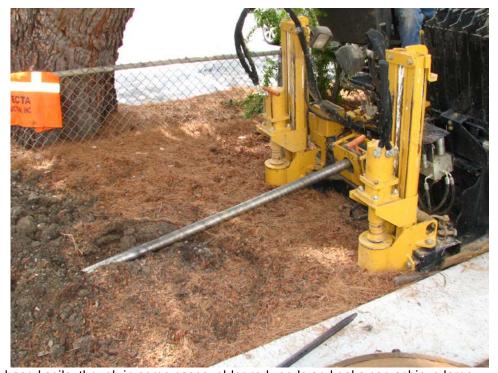
Typical woody lateral root growth extends from trees at least 3X to 5X the canopy dripline radius per previously published arboriculture science texts. This growth is generally present between grade elevation (i.e. soil surface) and down to approximately 24 inches below

grade in our western Bay Area urban clay-based soils, though in some cases, older redwoods and oaks can achieve large diameter woody root growth at depths as far as 50 to 60 inches below grade⁸

For tree stability maintenance, it is acceptable to sever roots at locations within 25 to 30 feet of large diameter coast redwoods and shamel ash. However, utility trenching within 25 feet of those trees may cause severe negative impacts to the trees' health and structural condition, resulting in premature decline and/or death. In those cases where utilities need to be routed within 25 feet of large trees being retained, WLCA suggests using pit to pit directional bore technology whereby conduit is pushed and pulled **below** the root systems of trees being retained, thereby allowing for almost complete root preservation when done correctly. See image of pit to pit directional bore in action below on one of my projects in the Bay Area. In this particular case, the bore started above ground, and ended at a pit. Typical method would be to start and end at a small dug pit.

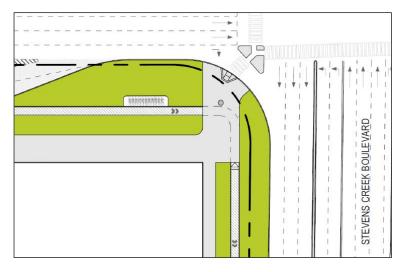
WLCA's main concern in areas such as this involves demolition crew activities during removal of surface hardscape and deep curbs, which may be comingled with existing woody tree root systems. When pulling out the curbs and hardscape piece by piece, these roots may become tangled with the machinery bucket teeth and be pulled, ripped, or otherwise destroyed or

damaged in the process. Therefore, an arborist monitor is suggested during demolition of any material within approximately 20 feet of a tree to be retained. As noted above in this report, we know that woody tree roots can extend laterally as far as 3x to 5x the canopy dripline distance from the trunk edge, which means that a 20 foot radius canopy tree may theoretically have roots extending as far as 60 to 100 feet radius out from trunk, even under asphalt, if there are no physical impediments to growth extension such as deep curbs or deep foundation footings.

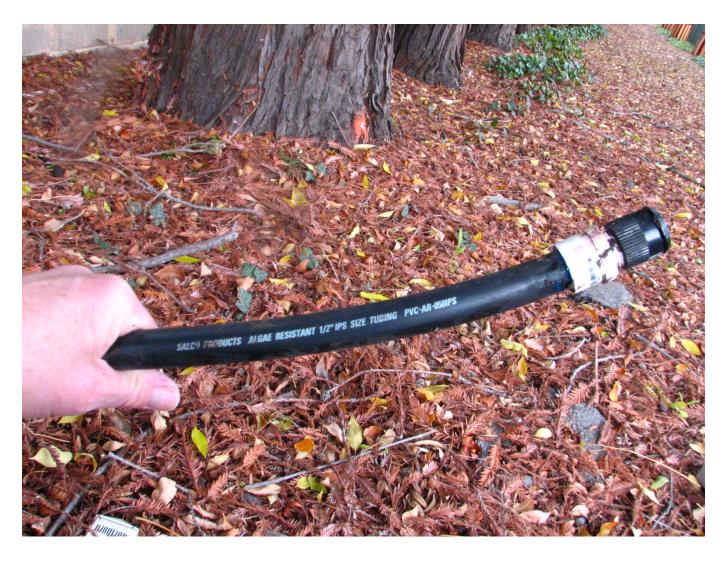
Above: Salco brand heavy duty UV-resistant flexible PVC irrigation tubing (1/2" diameter), with $\frac{1}{2}$ " diameter flood bubblers providing heavy flood flow when activated. This system is currently in use along our west perimeter road trees as temporary over-grade irrigation. The nice thing about this system is that it can be used for temporary and for permanent irrigation systems laid directly over-grade, due to its heavy duty thick-walled construction, and UV resistance rating. Standard schedule 40 PVC components (i.e. the white components) can be solvent-welded (cold blue glued) to the flex pipe using standard PVC blue glue.
