Assessment of 995 Trees at The Rise (Proposed Project) (Formerly known as Vallco Town Center Project) North Wolfe Road Cupertino, California

Walter Levison, Consulting Arborist (WLCA)

10/5/2015 Revised 6/14/2019 & 3/23/2022

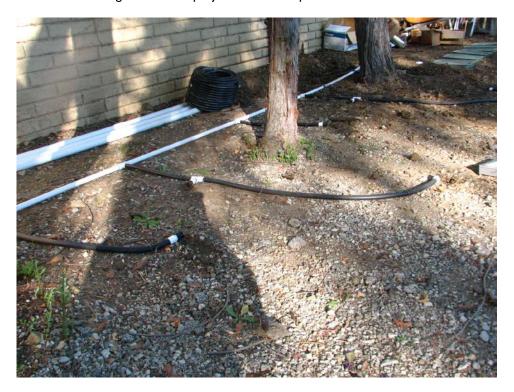
Above: Image of the new 2019 temporary flood bubbler irrigation system set over-grade along the west side of west perimeter road, with flexible UV-resistant Salco brand tubing cold-welded to white PVC main lines. This type of high flow system is going to be built up throughout the entire project site over time, as planned demolition expands out from this initial phase along west perimeter road.

Note: The team has been directed to place the bubblers as far as possible offset from the trunks of the trees, with the understanding that roots extend as much as 50 feet or more from the trunks. Bubblers on the west perimeter road temporary tree irrigation system were required to be placed near to the trunks in order to allow for golf carts and other vehicles to pass over the root zone.

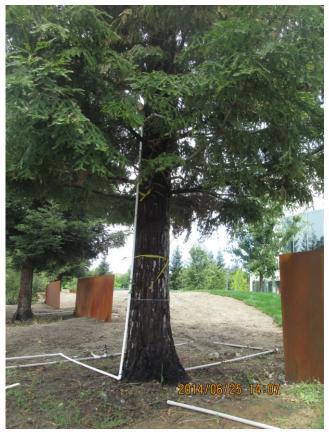
Even after this type of serious irrigation regime commences and is continued for the extended period, the trees may still not respond favorably, and will continue to decline. High quality irrigation water with low ionic content needs to be available for supplemental irrigation of coast redwoods. See section 3.4 and 3.5 below for more information.

It is not clear whether tree vigor (new live twig and foliar growth) will be or can be boosted through either very heavy, sustained supplemental irrigation of the trees' root zones, or through natural rainfall finally occurring after the (existing) prolonged period of subnormal soil moisture. Generally, trees that decline to an overall condition rating of poor (i.e. less than 50%) will not increase in vigor until very heavy irrigation is applied over an extended period of 6, 12, or even 18 months¹ to the trees' entire root zone areas.

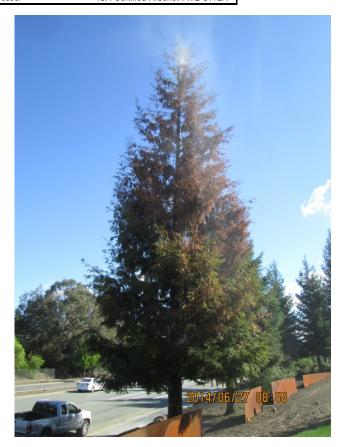
Above right is an image of an actual installed aerial misting system in use on local peninsula Bay Area project redwood specimen. These systems would require a

Optionally, we could install some type of fogging system to augment moisture uptake by the trees by adding fog water to some lower canopy or mid canopy locations. Redwoods in their natural range along the Northern California coast and Oregon coast forests derive a significant percentage of their water moisture through direct acquisition of fog water through their needles². Thus, use of a fogging system could potentially be of great benefit to the trees, if such as system could be affixed to locations near canopies at varying elevations above grade.

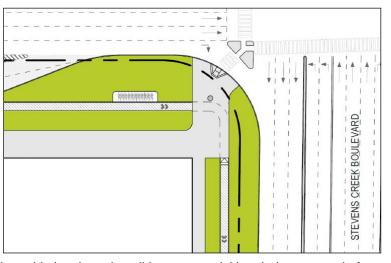
Demolition of existing curbs, planting areas, asphalt parking stall surface materials, etc. to make way for new landscaping may cause significant or severe damage to the below ground portions of trees being retained such as shamel ash at the southwest end of the site along the south boundary of the former Sears parking lot (see sample blowup at right, showing proposed planting plan, street level, sheet P-0605, January, 2018 iteration).

WLCA's main concern in areas such as this involves demolition crew activities during removal of surface hardscape and deep curbs, which may be comingled with existing woody tree root systems. When pulling out the curbs and hardscape piece by piece, these roots may become tangled with the machinery bucket teeth and be pulled, ripped, or otherwise destroyed or damaged in the process. Therefore, an arborist monitor is suggested during demolition of any material within approximately 20 feet of a tree to be retained. As noted above in this report, we know that woody tree roots can extend laterally as far as 3x to 5x the canopy dripline distance from the trunk edge, which means that a 20 foot radius canopy tree may theoretically have roots extending as far as 60 to 100 feet radius out from trunk, even under asphalt, if there are no physical impediments to growth extension such as deep curbs or deep foundation footings.

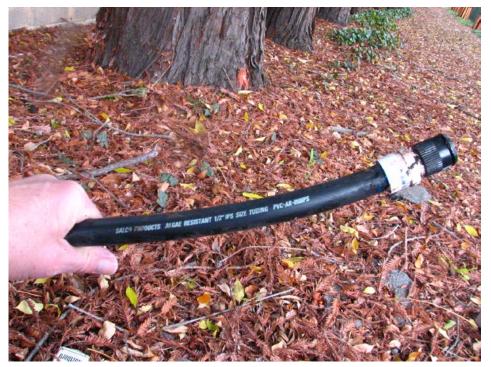
Above: Salco brand heavy duty UV-resistant flexible PVC irrigation tubing (1/2" diameter), with ½" diameter flood bubblers providing heavy flood flow when activated. This system is currently in use along our west perimeter road trees as temporary over-grade irrigation. The nice thing about this system is that it can be used for temporary and for permanent irrigation systems laid directly overgrade, due to its heavy duty thick-walled construction, and UV resistance rating.

Use a UV-resistant type flexible PVC pipe that can be laid directly over-grade in sunlight. This type of piping is typically the Salco brand flexible tubing "1/2 inch" diameter pipe that is already in use on the project site by the property owner for our innovative temporary irrigation system which supplies heavy water volume via high flow type ½" diameter flood bubblers on an AC timer operated system. A digital image of this system is included below for reference.
