COPERTINO CIVIC CENTER MASTER PLAN DOCUMENT APPENDICES

The Civic Center Master Plan (CCMP) Document Appendices accompanies the CCMP Document. The CCMP Document is a summary of the planning process that began in 2012 as the Civic Center Master Plan Framework study and culminated at a Civic Center Master Plan, developed as directed by the City Council on October 21st, 2014.

This Appendix is a comprehensive collection of surveys, analysis and findings from studies carried out through the Civic Center Master Planning process. These are documented here as the following memorandums and presentations.

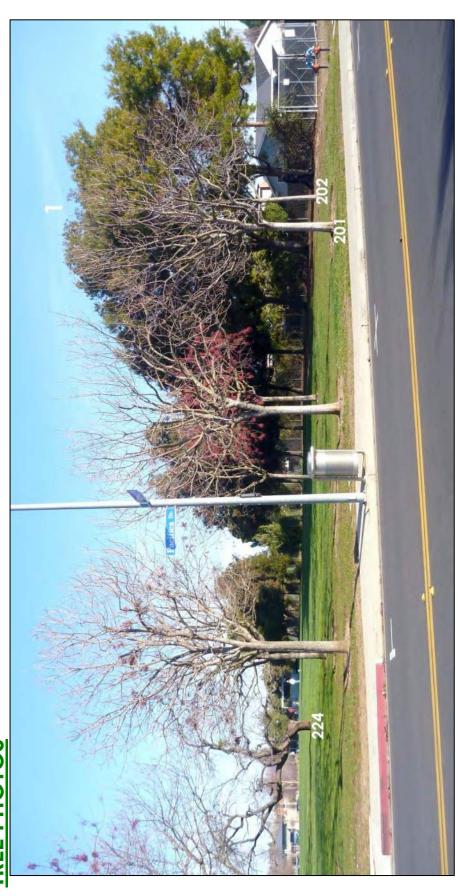
Pacifica Drive (foreground) with the creek perimeter at right. Tree numbering begins with the row of black acacia trees starting with tree #1. In the foreground is a double row of Chinese pistache trees including trees #201 and 202. Old black walnut #224 is in the background at left.

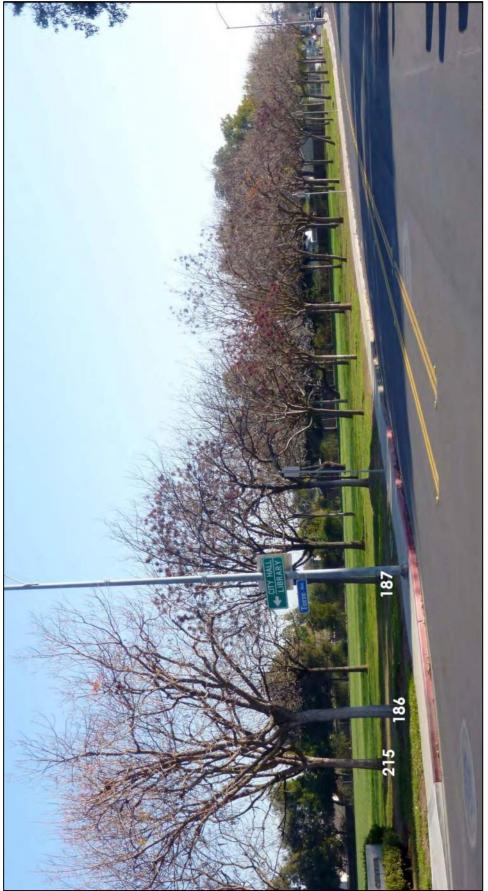
The corner of Pacifica Drive (right, foreground) with Torre Avenue to the left. The triple row of Chinese pistache trees is visible, with trees #186, 187 and 215 labeled.

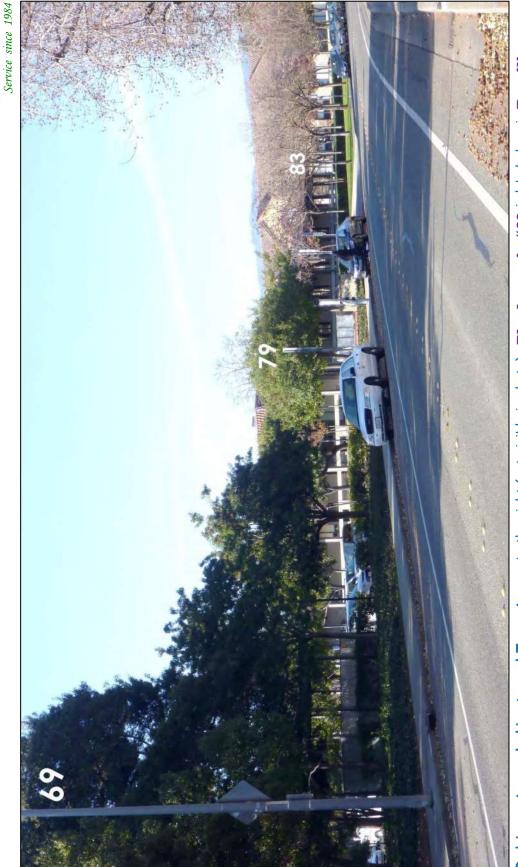
Rodrigues Avenue looking toward Torre Avenue to the right (not visible in photo). Black acacia #69 is labeled, as is Brazilian pepper #79 and Chinese pistache #83.

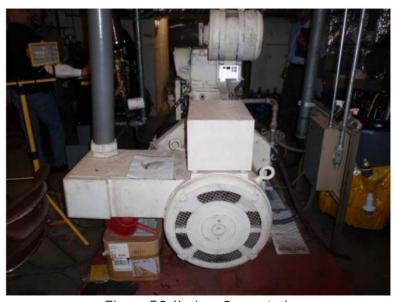
Figure 5G (Indoor Generator)

The emergency power system consists of a generator rated at 125KW, 208/120V and is located inside the main electrical room. The fuel tank, with 1000 gallon capacity, is located outside the room. In the event of a power outage, the generator provides power to the panel DP via a 400A automatic transfer switch (ATS) located in the main electrical room. The generator also provides power to the Chiller but the pump must be "jump" to move chilled water. The generator does not serve the existing elevator. or the chiller, as confirmed by discussions with facility personnel.

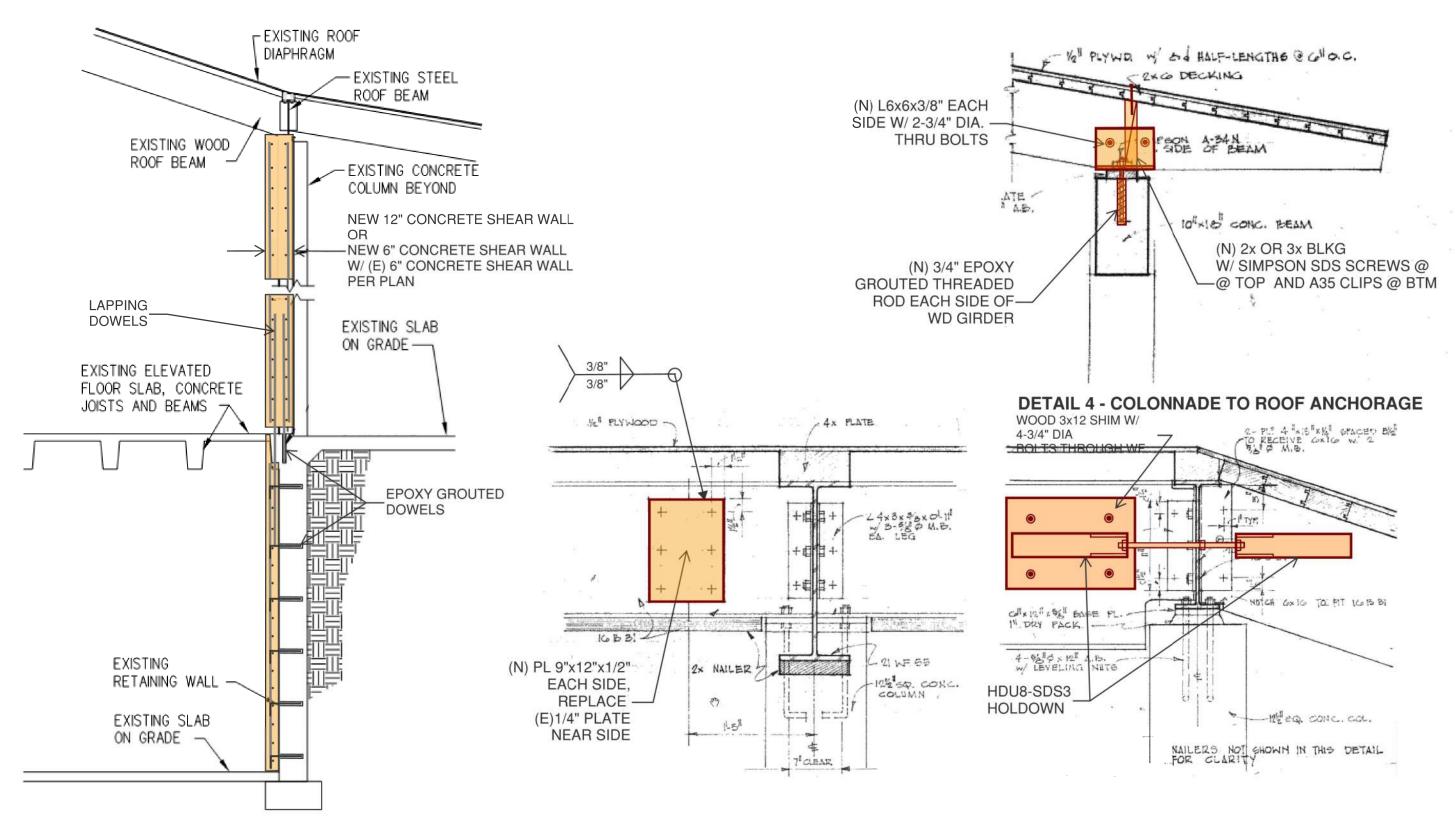
DETAIL 3 - SECTION AT NEW CONCRETE SHEAR WALL

DETAIL 2 - STEEL TO STEEL COLLECTOR SPLICE

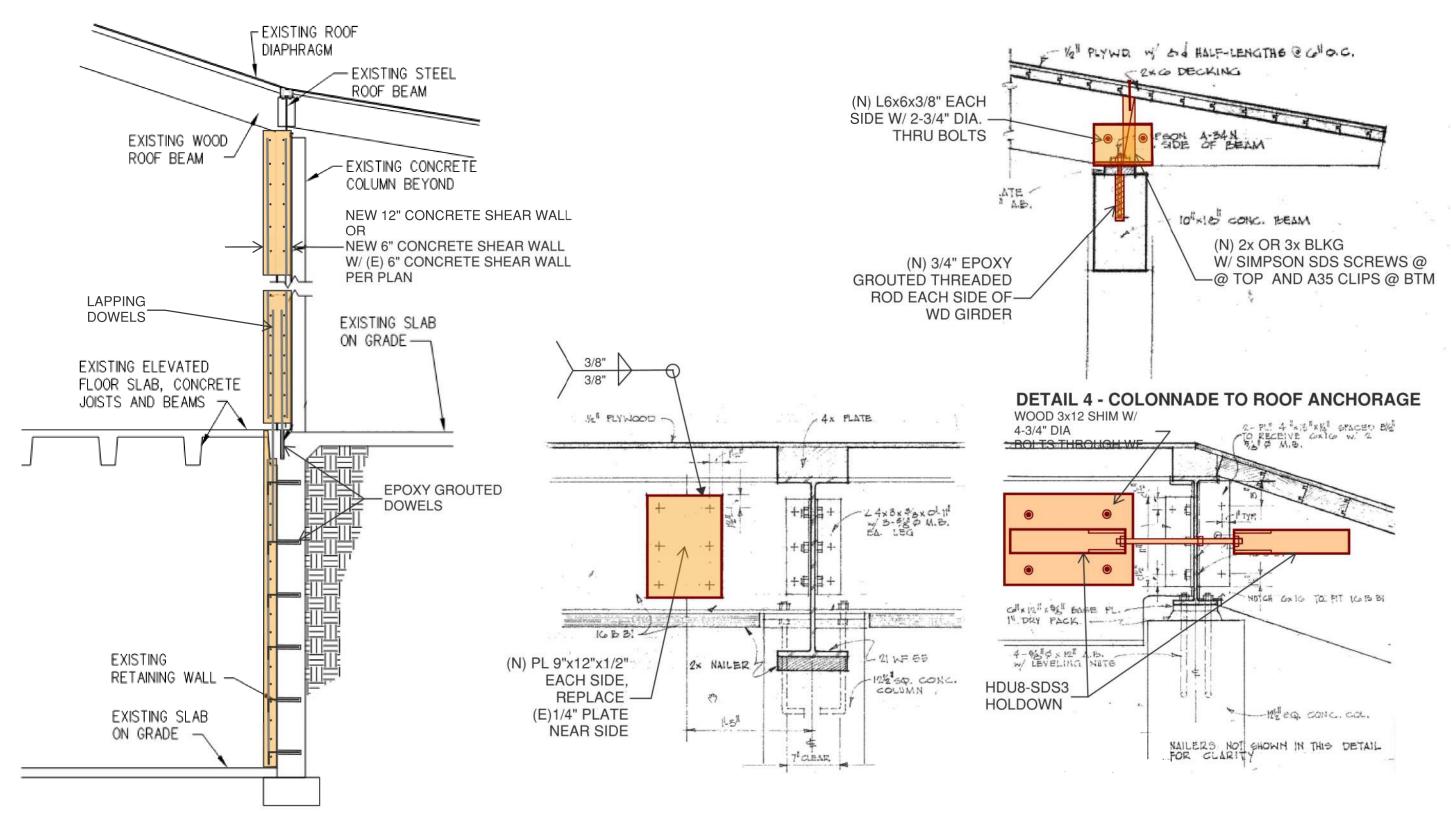
DETAIL 3 - SECTION AT NEW CONCRETE SHEAR WALL

DETAIL 2 - STEEL TO STEEL COLLECTOR SPLICE
