ENVIRONMENTAL SITE MANAGEMENT PLAN

FORMER VALLCO SHOPPING MALL
10123 NORTH WOLFE ROAD,
CUPERTINO, CALIFORNIA

APRIL 2019
REVISED JULY 2019

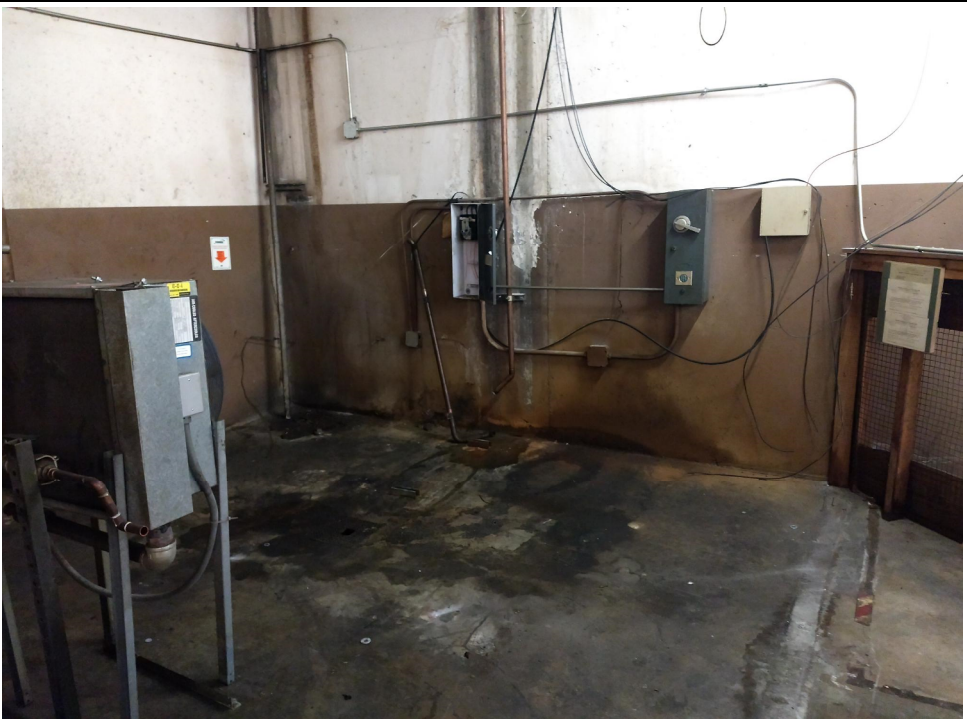
Photo No.	Date	
7	March 25, 2019

<p>Basement level of the former Sears Automotive Center. Three wipe samples to be collected in areas of staining on the floor and three wipe samples along the wall.</p>

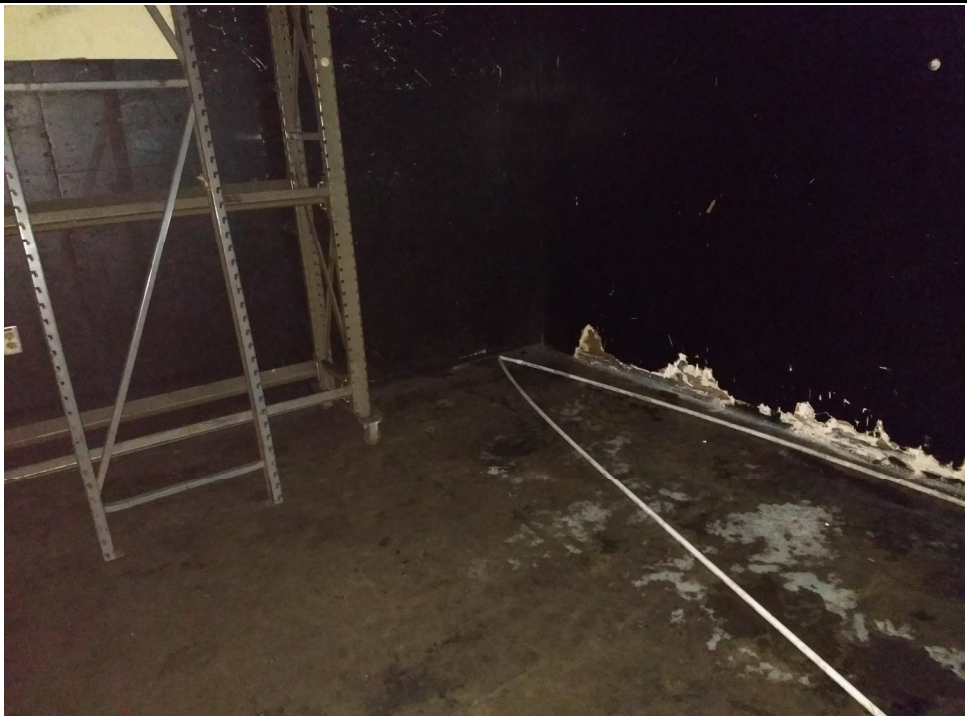
<p>9</p>	<p>March 25, 2019</p>	 
<p>Basement level of the former Sears Automotive Center. Three wipe samples to be collected in areas of staining on the floor and three wipe samples along the wall, above the areas of staining.</p>

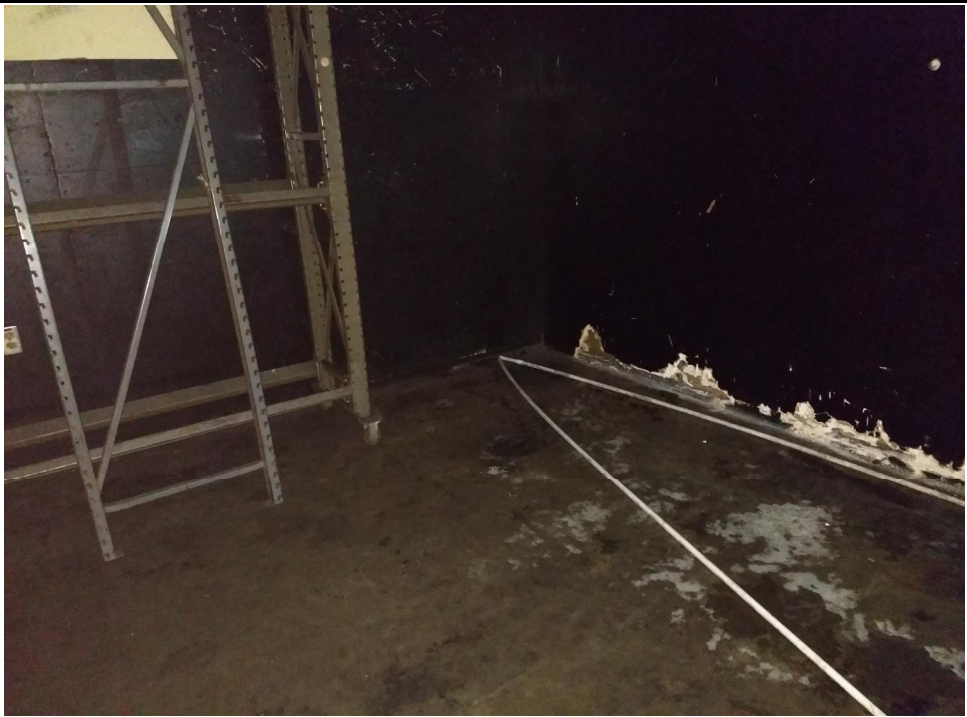
<p>9</p>	<p>March 25, 2019</p>

<p>Basement level of the former Sears Automotive Center. Three wipe samples to be collected in areas of staining on the floor and three wipe samples along the wall, above the areas of staining.</p>
