Assessment of 995 Trees at The Rise (Proposed Project) (Formerly known as Vallco Town Center Project) North Wolfe Road Cupertino, California

Walter Levison, Consulting Arborist (WLCA)

10/5/2015 Revised 6/14/2019 & 3/23/2022

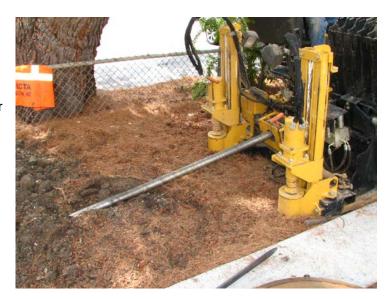
For tree stability maintenance, it is acceptable to sever roots at locations within 25 to 30 feet of large diameter coast redwoods and shamel ash. However, utility trenching within 25 feet of those trees may cause severe negative impacts to the trees' health and structural condition, resulting in premature decline and/or death. In those cases where utilities need to be routed within 25 feet of large trees being retained, WLCA suggests using pit to pit directional bore technology whereby conduit is pushed and pulled **below** the root systems of trees being retained, thereby allowing for almost complete root preservation when done correctly. See image of pit to pit directional bore in action below on one of my projects in the Bay Area. In this particular case, the bore started above ground, and ended at a pit. Typical method would be to start and end at a small dug pit.
