ENVIRONMENTAL SITE MANAGEMENT PLAN

FORMER VALLCO SHOPPING MALL
10123 NORTH WOLFE ROAD, CUPERTINO, CALIFORNIA

APRIL 2019
REVISED JUNE 2019

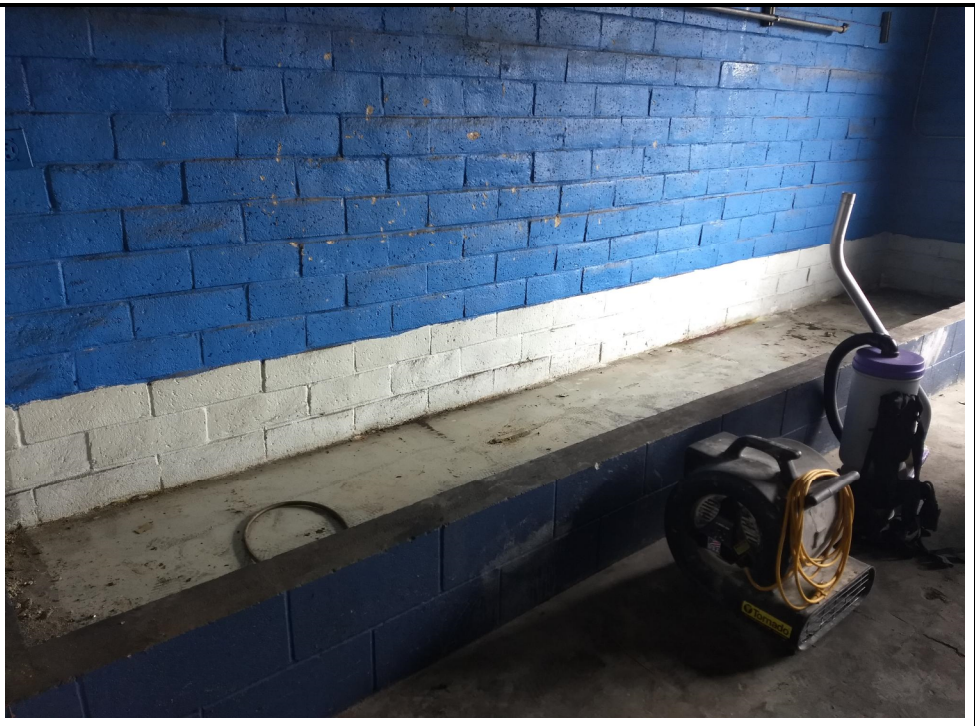
Photo No.	Date
1	March 25, 2019

Northeast corner of former Sears Automotive Building, first floor.
Three wipe samples will be collected along the floor and three along the wall.

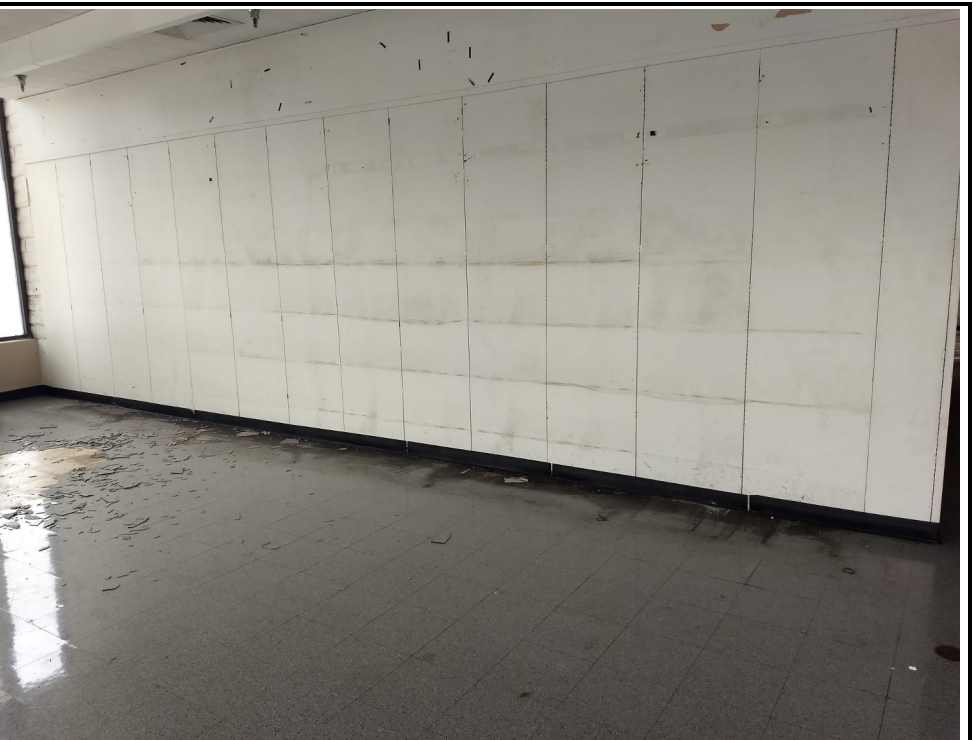
Photo No.	Date
2	March 25, 2019

South portion of former Sears Automotive Building, first floor.
Former battery storage area. Three wipe samples will be collected along the floor and three along the wall.

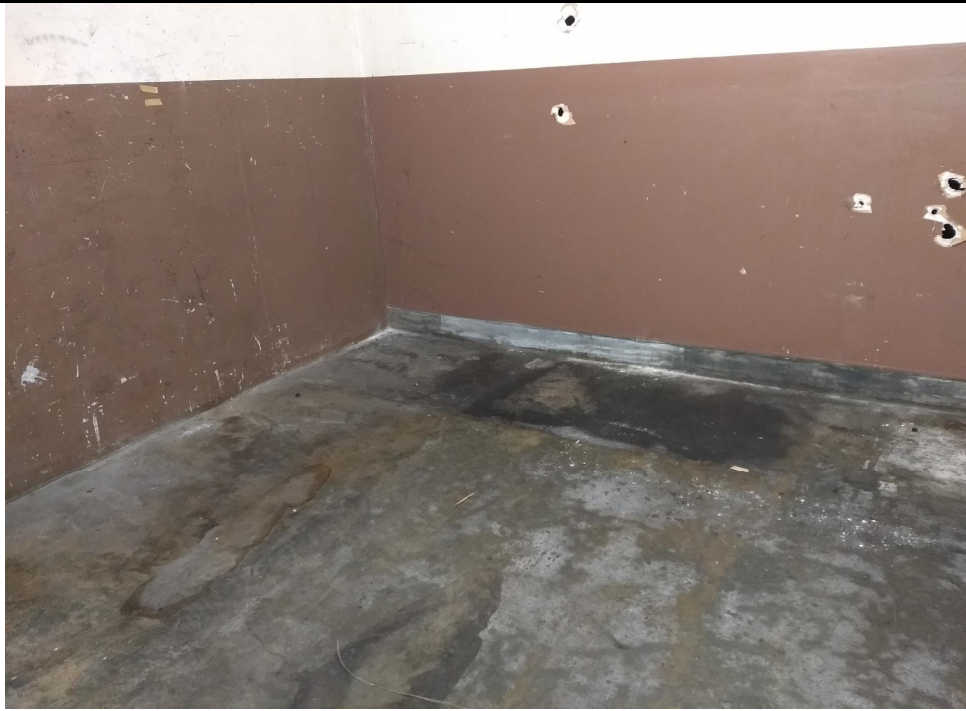
Photo No.	Date	
4	March 25, 2019

<p>Basement level of the former Sears Automotive Center. Three wipe samples to be collected along the floor, adjacent to each side of the side walls and one in the corner. Three wipe samples will be taken on the wall above where each floor sample is collected.</p>

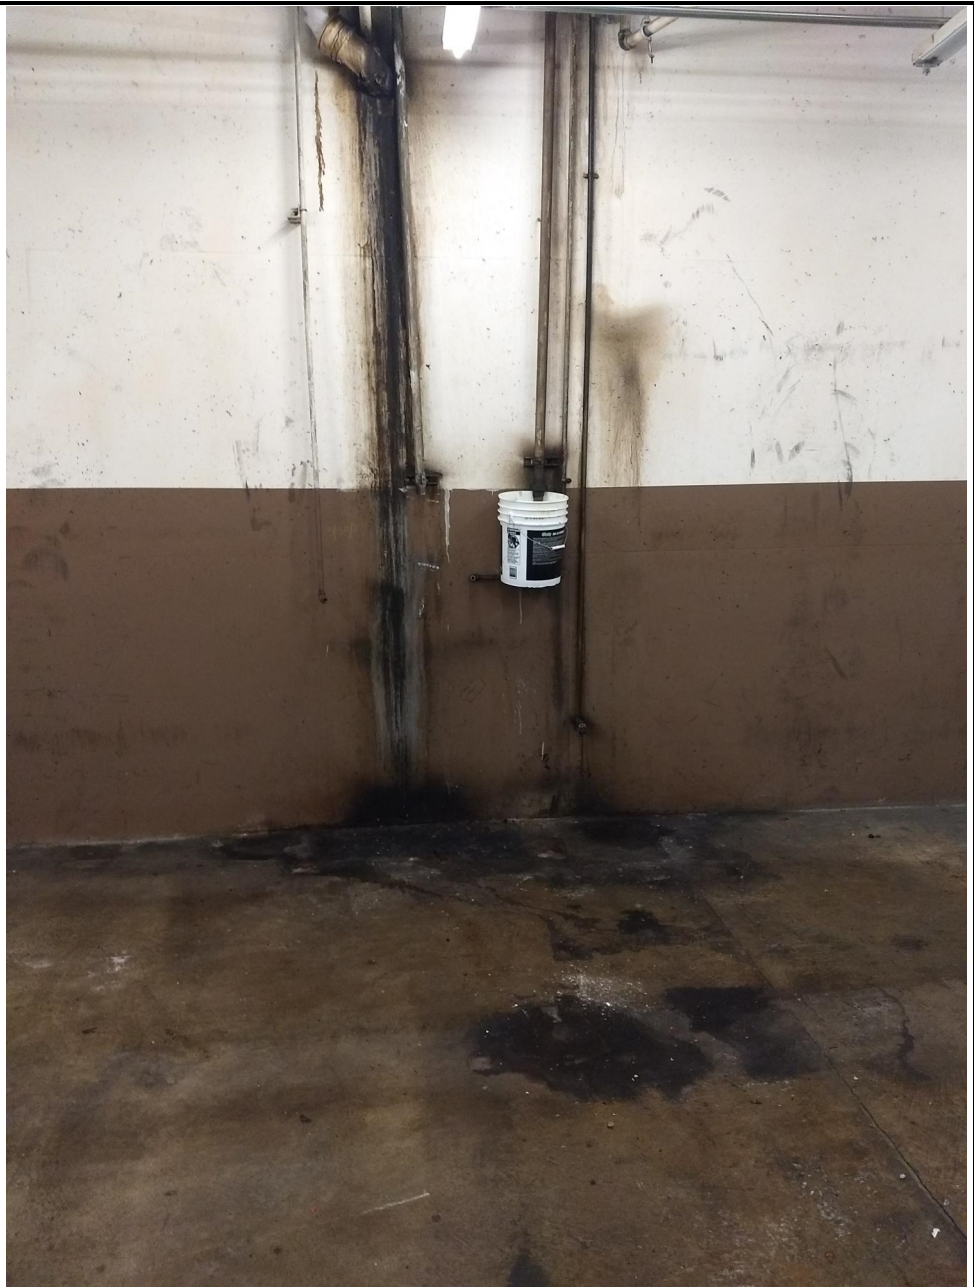
Photo No.	Date
5	March 25, 2019

Basement level of the former Sears Automotive Center. Two wipe samples to be collected in areas of staining on the floor and two wipe samples along the wall, above the areas of staining.

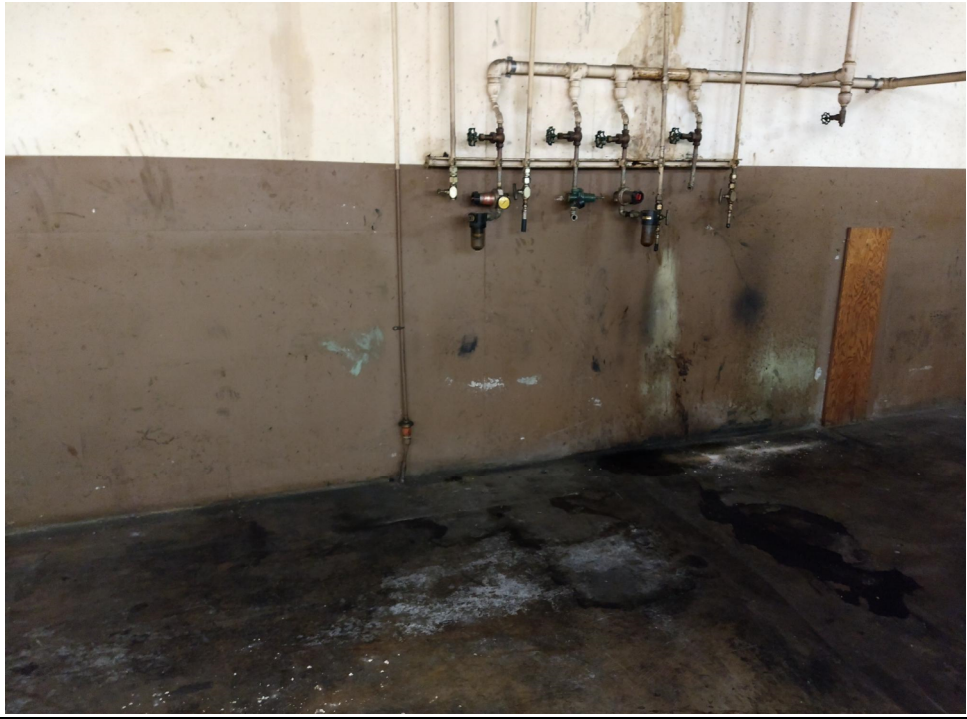
Photo No.	Date	
6	March 25, 2019

<p>Basement level of the former Sears Automotive Center. Two wipe samples to be collected in areas of staining on the floor and two wipe samples along the wall, above the areas of staining.</p>

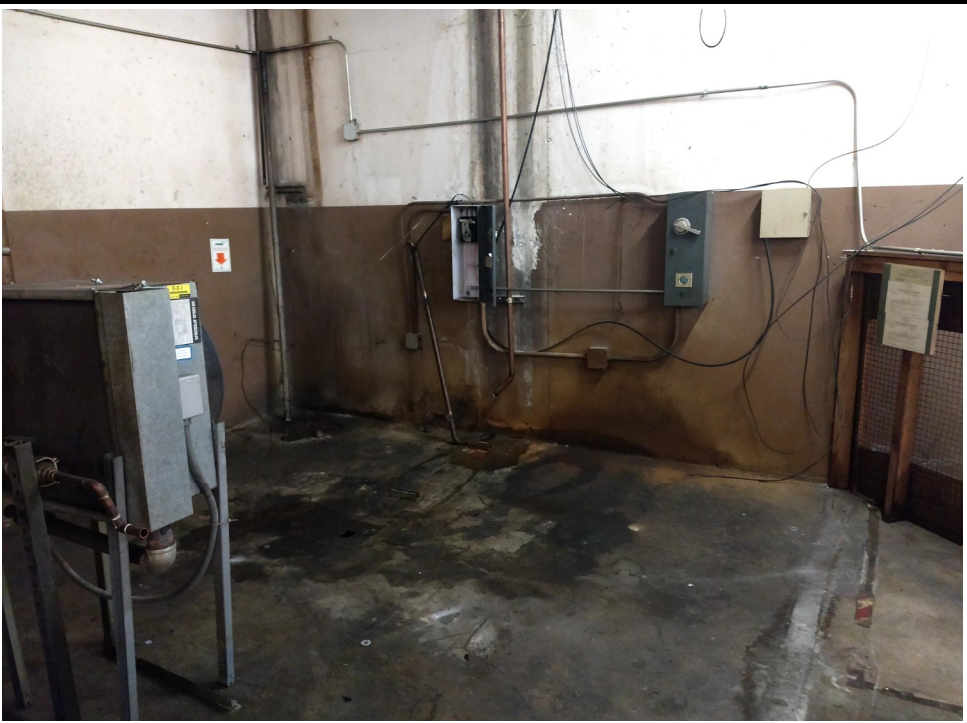
Photo No.	Date	
7	March 25, 2019

<p>Basement level of the former Sears Automotive Center. Three wipe samples to be collected in areas of staining on the floor and three wipe samples along the wall.</p>

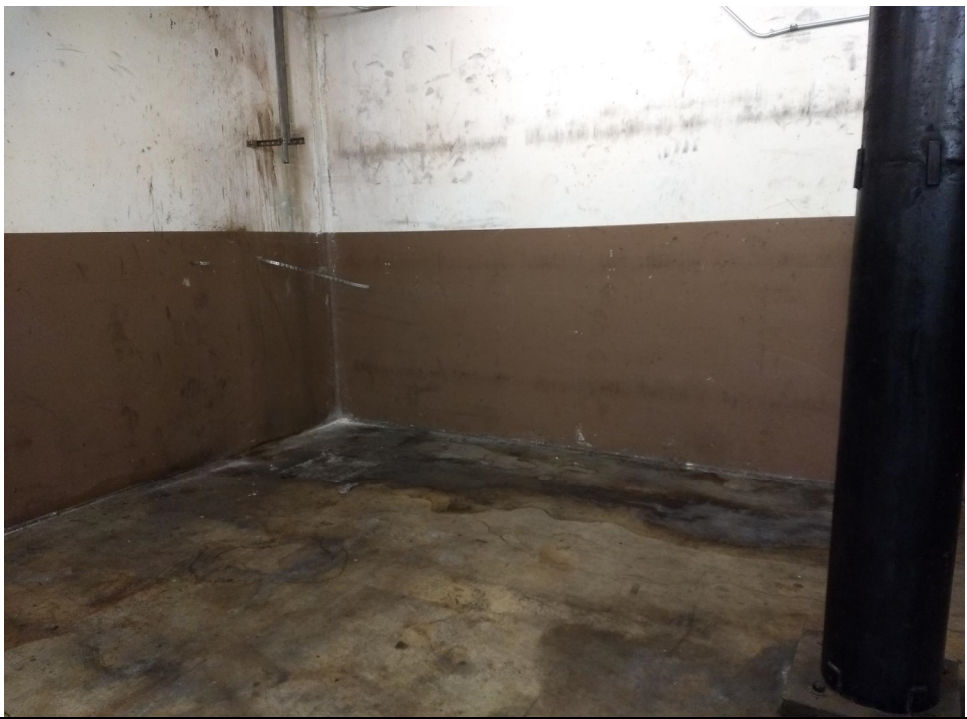
<p>8</p>	<p>March 25, 2019</p>

<p>Basement level of the former Sears Automotive Center. Three wipe samples to be collected in areas of staining on the floor and three wipe samples along the wall, above the areas of staining.</p>

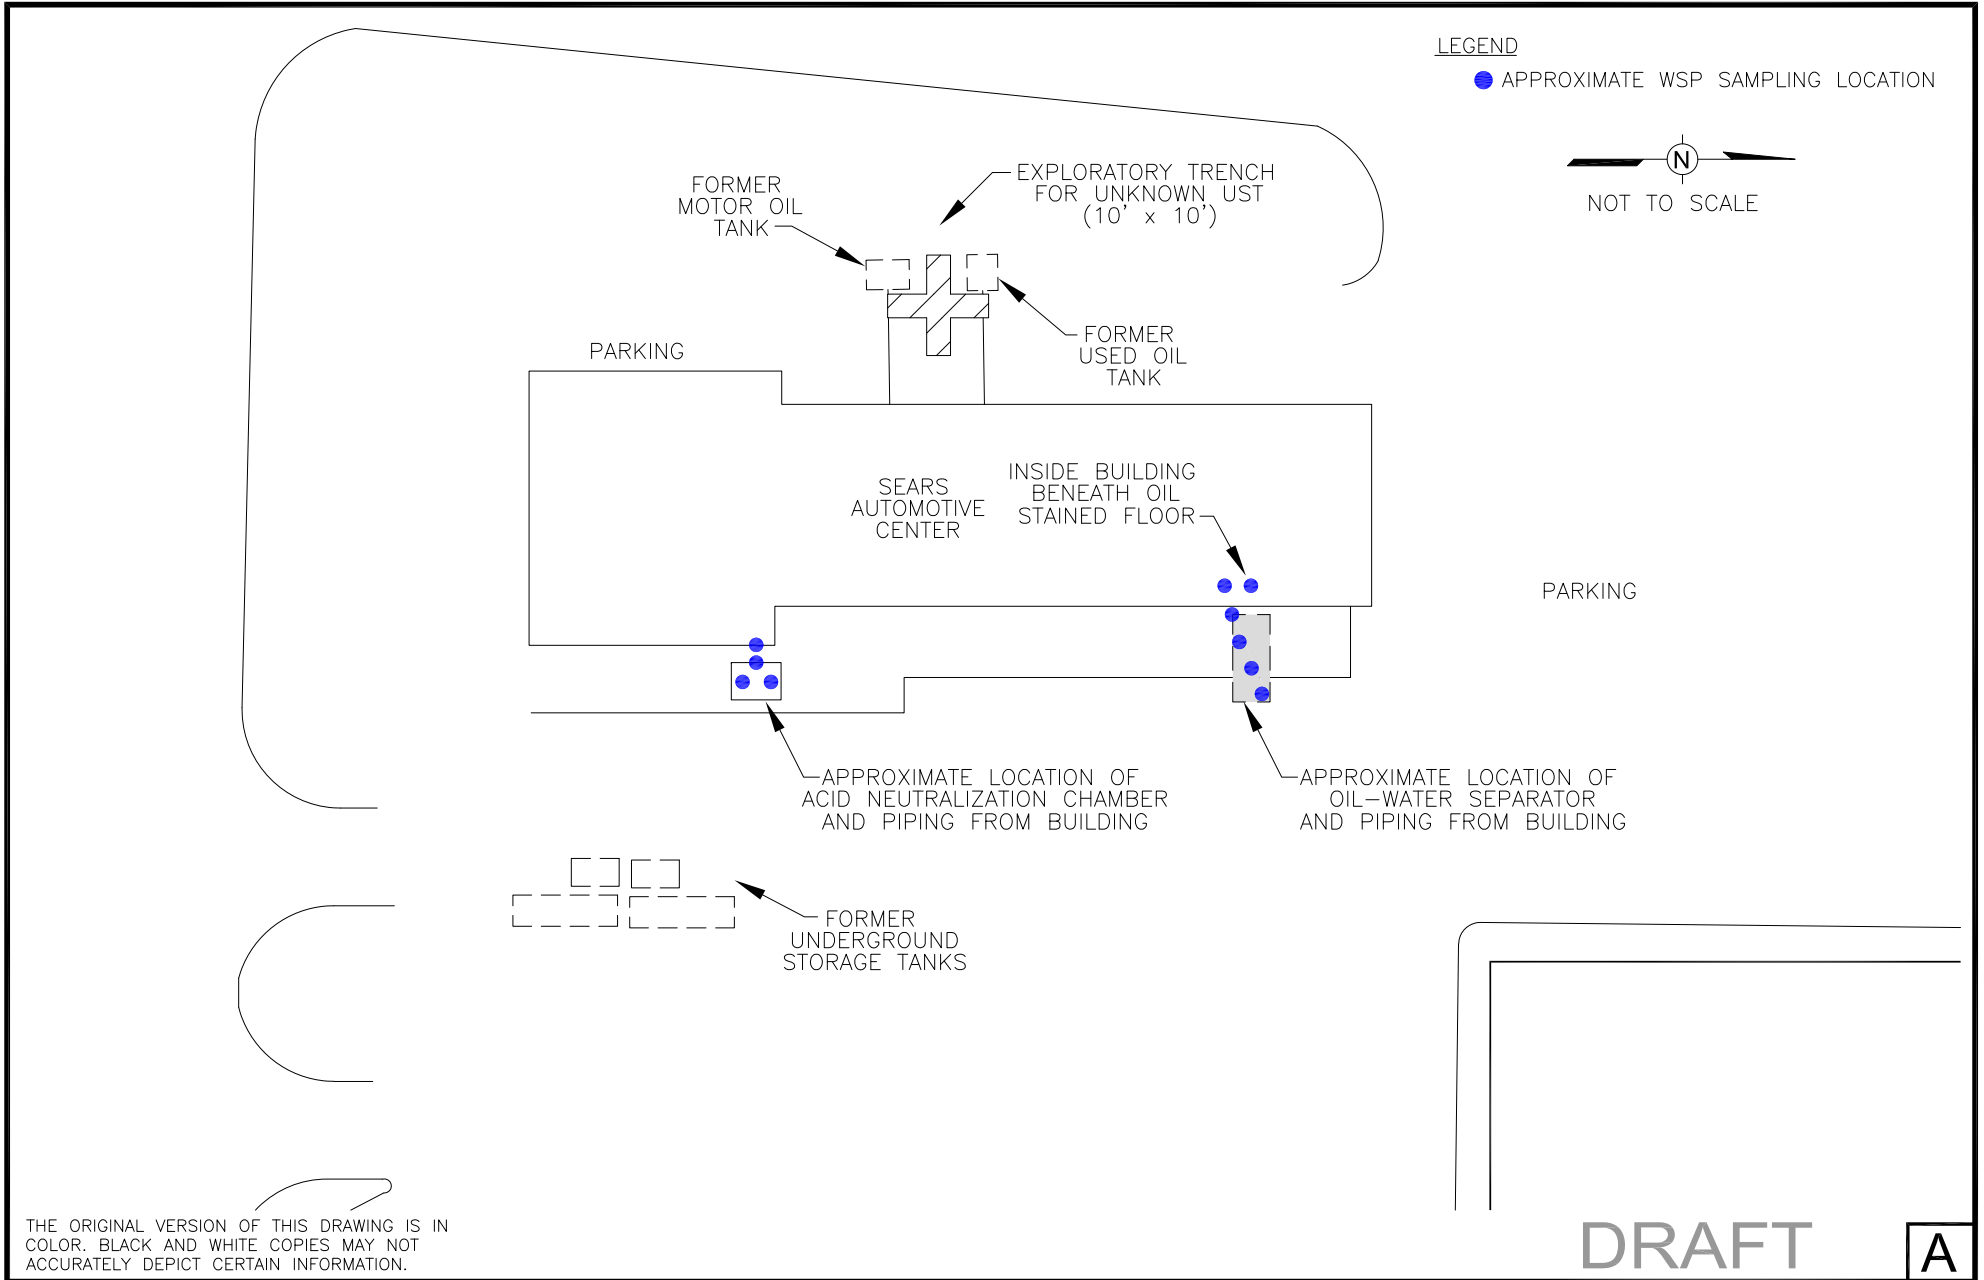
<p>WSP USA Inc. 2025 GATEWAY PLACE SUITE 348 SAN JOSE, CA 95110 TEL: +1 408.453.6100</p>	<p>Figure 1</p>	<p>VALLCO FASHION MALL 10123 NORTH WOLFE ROAD CUPERTINO, CALIFORNIA PREPARED FOR SAND HILL PROPERTY COMPANY PALO ALTO, CALIFORNIA</p>	<p>Drawn By: LS 3/21/2019</p>
	<p>APPROXIMATE SAMPLING LOCATIONS – SEARS AUTOMOTIVE CENTER</p>		<p>Checked:</p> <p>Approved:</p> <p>DWG Name: 314MN1588-009</p>

- 2 Oil-Water Separator and Acid Neutralization Chamber: A below-ground oil/water separator exists outside the northeast corner of the building and a former acid neutralization chamber (previously emptied and closed by and filling with gravel) is located near the southeastern corner of the building (Figure 1). The oil/water separator and the acid neutralization chamber will be cleaned, as necessary, and the units removed for proper disposal. Following removal of the oil-water separator and acid neutralization chamber and any associated piping, soil samples will be collected from beneath the units and along the underground piping paths to determine if there were any significant releases. Preliminary proposed sample locations are shown on Figure 1 (attached). The soil samples will be analyzed for the following constituents per Santa Clara County guidelines :
