EXCAVATION MANAGEMENT PLAN REMOVAL ACTIONS IN WOLFE ROAD AND SEARS AREAS OF FORMER VALLCO MALL

DECEMBER 2020; Revised FEBRUARY 2021

10123 NORTH WOLFE ROAD CUPERTINO, CALIFORNIA

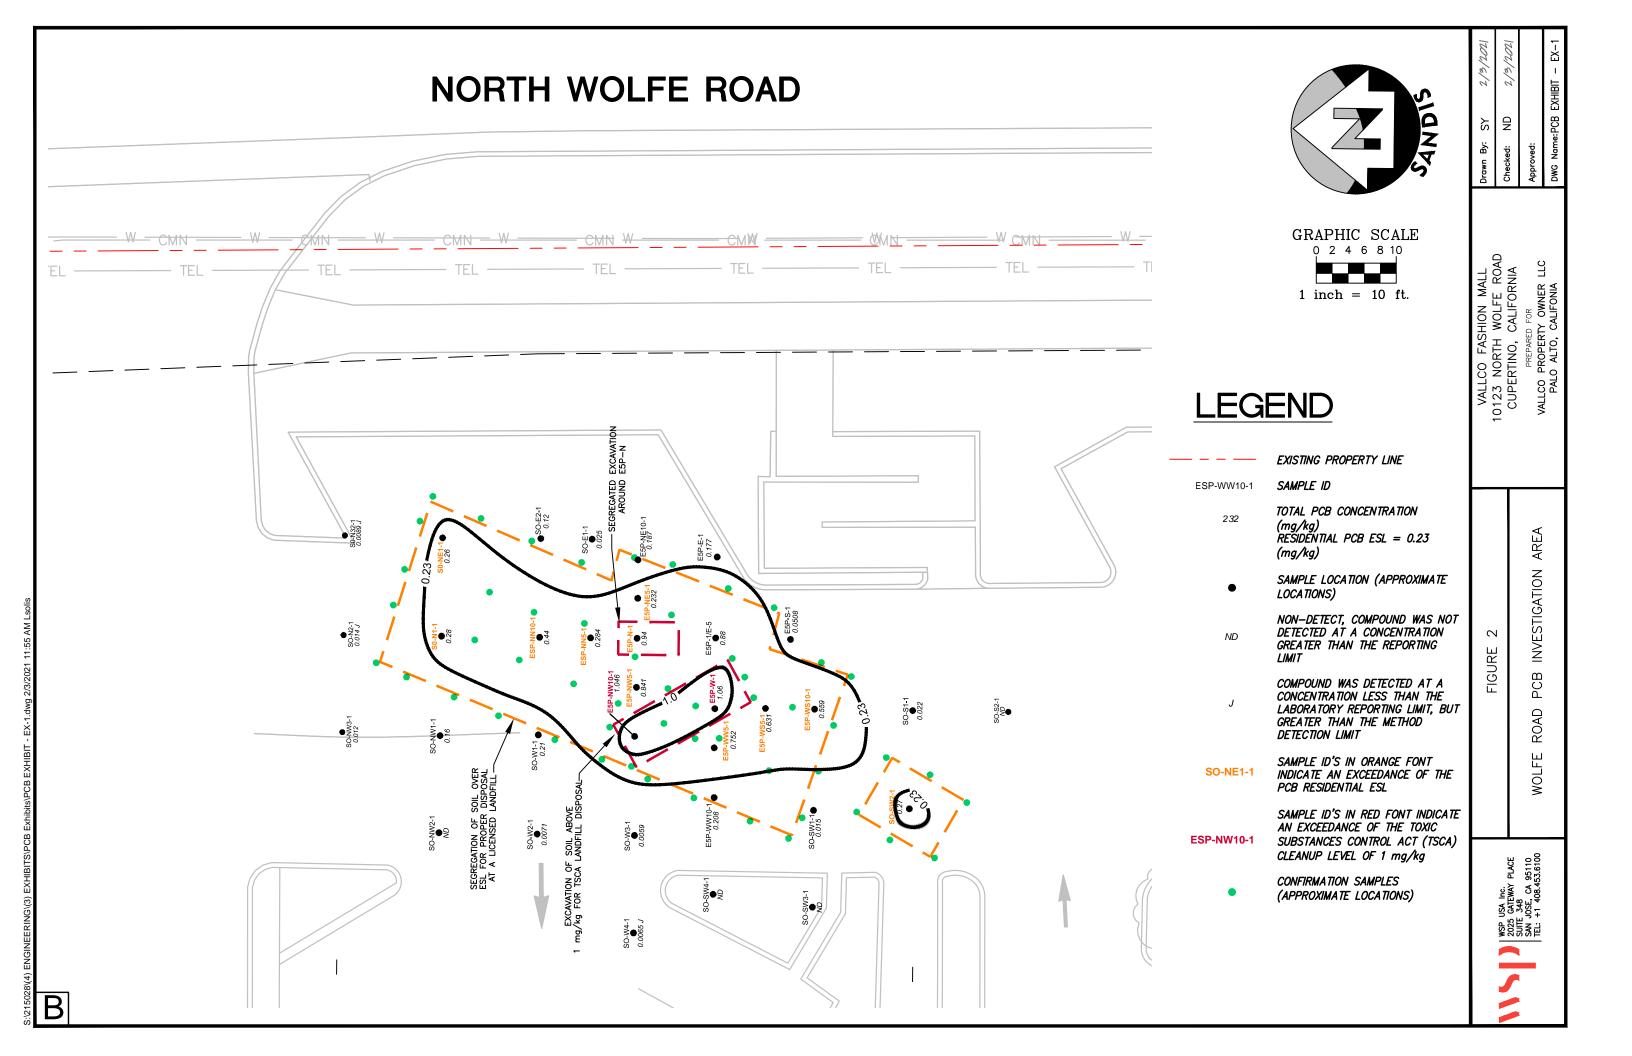
E5P-N-3-BASE OF EXCAVATION WOLFE ROAD AREA

5' * E5P-N-3 * 5' 5'

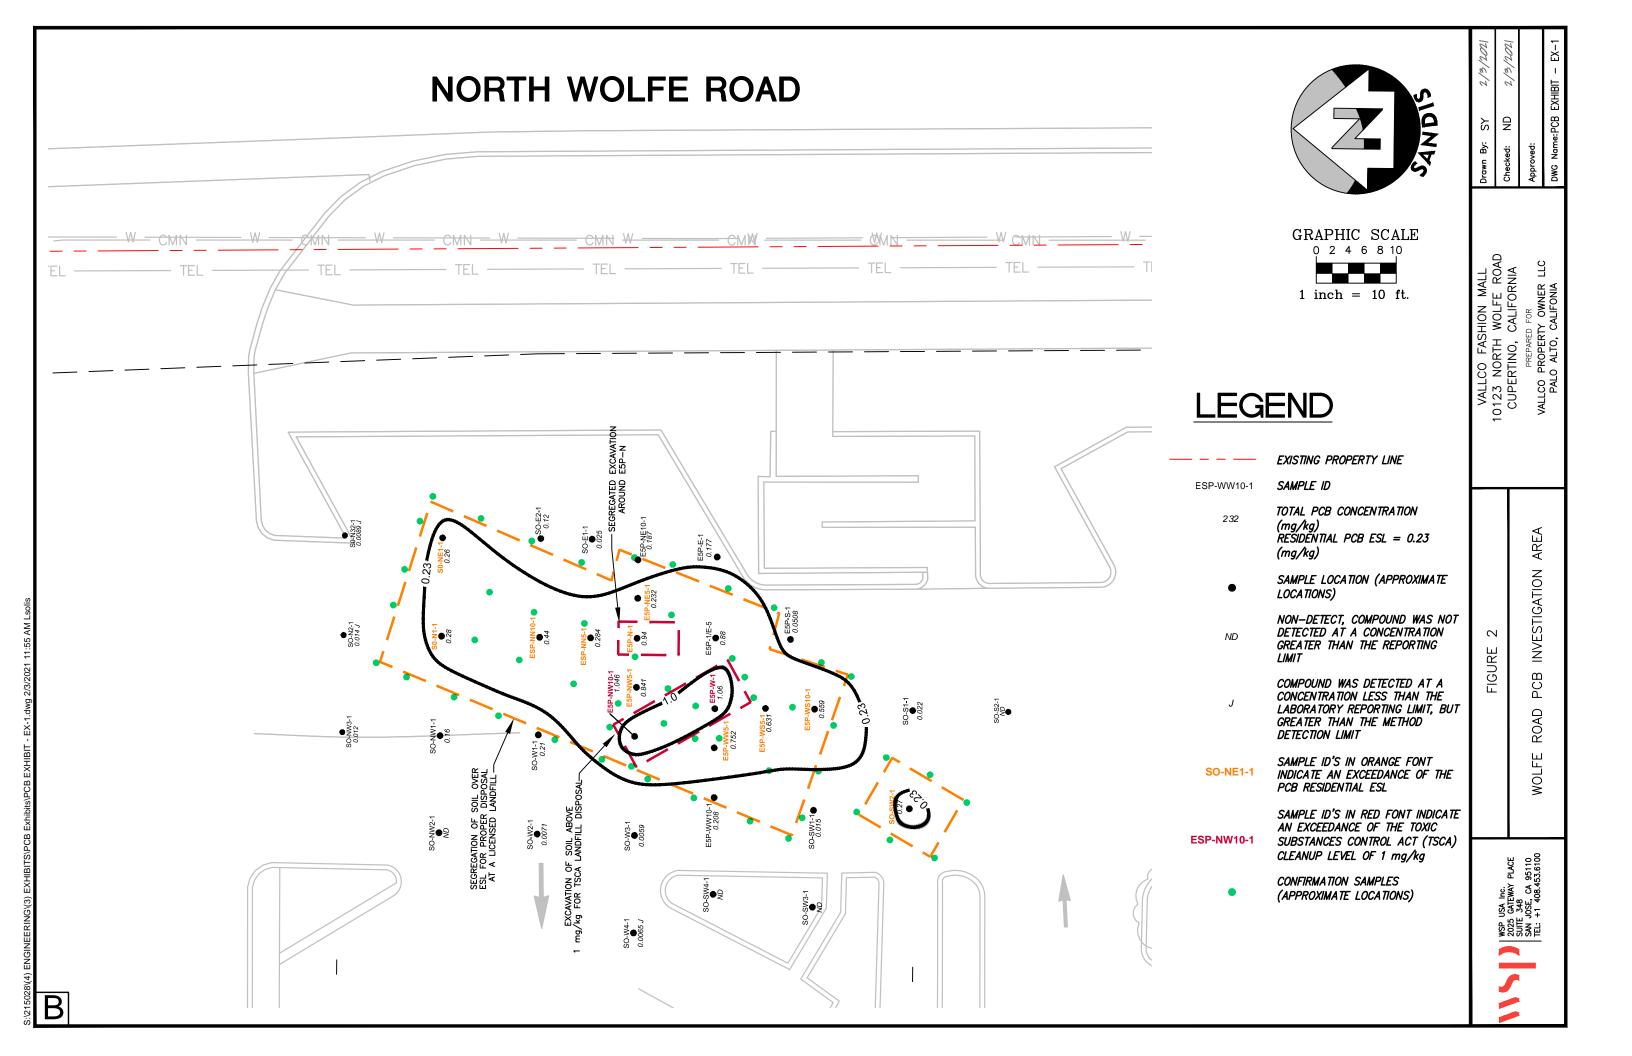
E5P-N-3-BASE OF EXCAVATION WOLFE ROAD AREA

5' * E5P-N-3 * 5' 5'

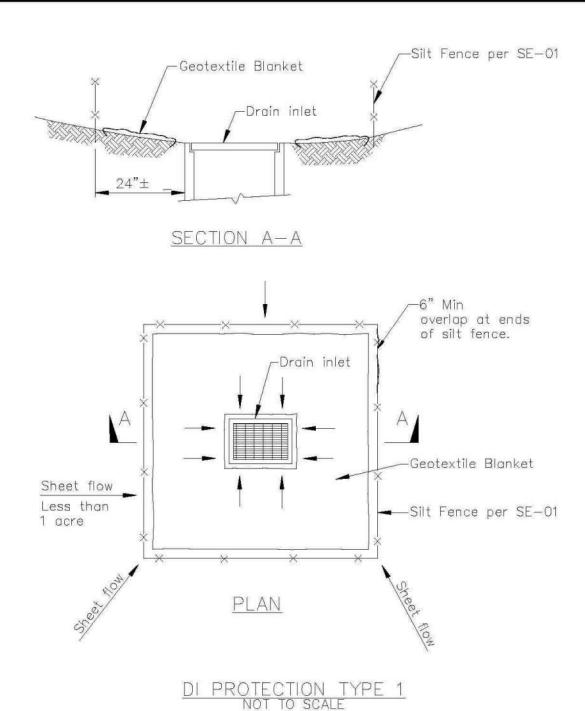
- 1. For use in areas where grading has been completed and final soil stabilization and seeding are pending.
- 2. Not applicable in paved areas.
- 3. Not applicable with concentrated flows.

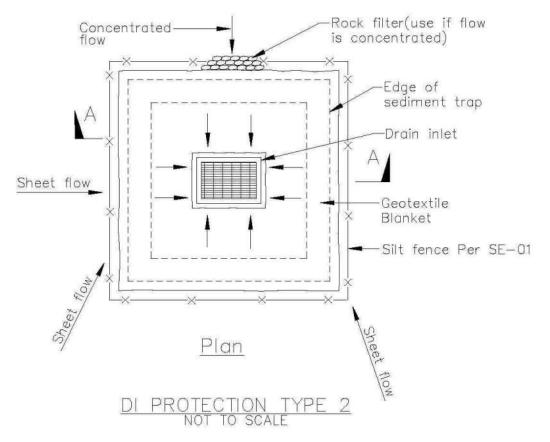
- 1. For use in cleared and grubbed and in graded areas.
- 2. Shape basin so that longest inflow area faces longest length of trap.
- 3. For concentrated flows, shape basin in 2:1 ratio with length oriented towards direction of flow.

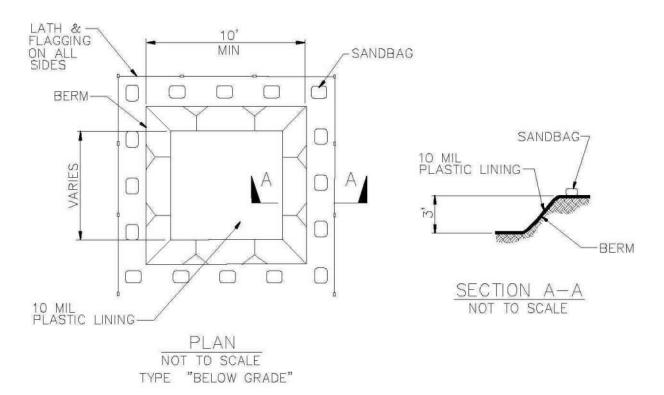
- 1. ACTUAL LAYOUT DETERMINED IN FIELD.
- 2. THE CONCRETE WASHOUT SIGN SHALL BE INSTALLED WITHIN 30 FT. OF THE TEMPORARY CONCRETE WASHOUT FACILITY.
